THE AGA KHAN TRUST FOR CULTURE

THE REVITALISATION OF THE  
GARDENS OF EMPEROR HUMAYUN'S TOMB, DELHI, INDIA

PROGRAMME BRIEF

*April 2003*

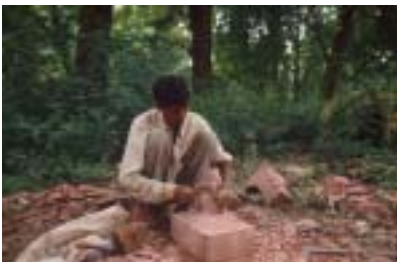
**Lime:** Lime mortar was used for all masonry work carried out as part of the collaborative project. The pathways, channels, platforms, minor structures and wells were all repaired using lime mortar mixed with traditional materials such as gur (molasses), bel-giri (fruit pulp), surkhi (brick dust), in addition to coarse sand. The lime was also prepared and cured using traditional techniques, such as the lime wheel, for compaction. The extensive use of this material was also used as a training ground for masons.

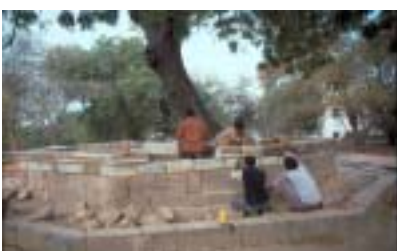
**Octagonal Platform:** On the northeast corner of the garden stands an octagonal platform that could have been used for a ceremonial royal tent. Constructed of local, dressed quartzite stone - one of the hardest stones known, the platform was in a state of dilapidation with the top two courses largely missing. These have now been restored using traditional tools and employing techniques in which the craftsmen were trained.

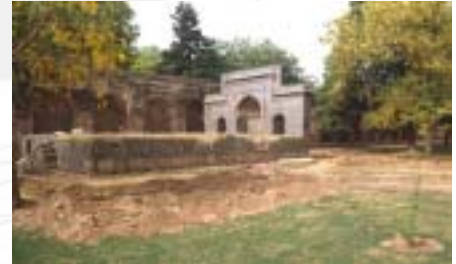
**Wall Mosque:** Along the southern enclosure wall of the garden, stands a wall mosque possibly dating from the 18<sup>th</sup>-19<sup>th</sup> century. Conservation work was undertaken on this mosque, which was in a dangerous state of structural instability.
